Country

Czech Republic

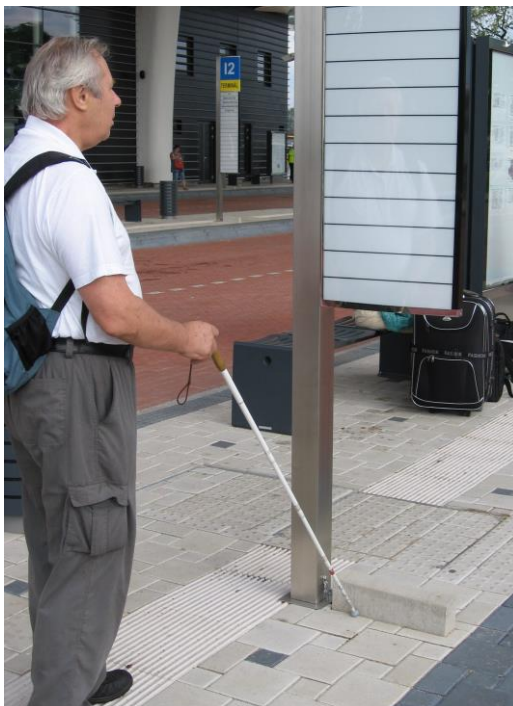
Stop block for white stick correctly placed in place bus stop (stop pillar).

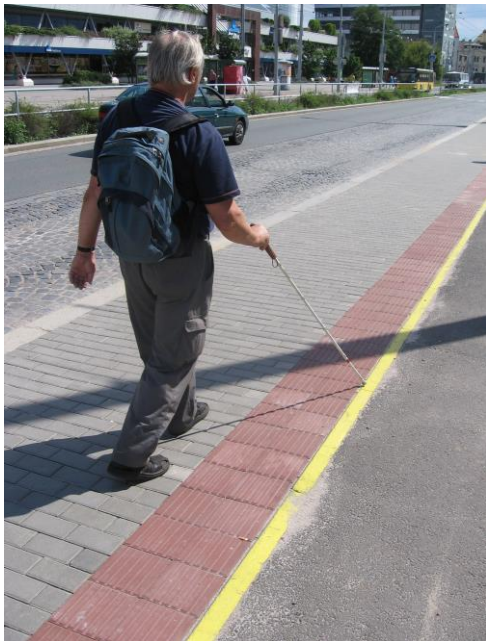
Guiding line for blind people

Tactile guiding line for blind people – correct material (surface - groove), colour and dimension (40 cm wide).

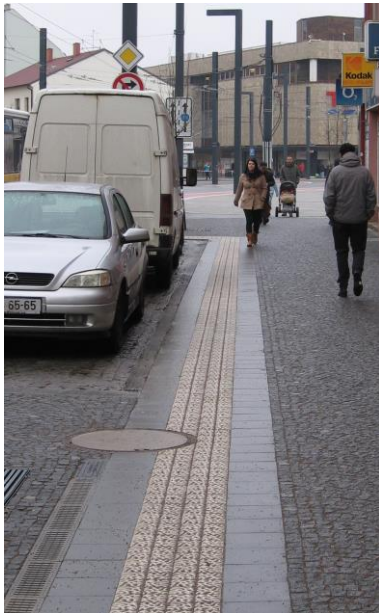
Parking place in the same level as pedestrian path

Correct arrangement (colour contrast tactile paving with plane paving in surround) at the interface between the pedestrian path and parking place in the same level. Important for blind people.

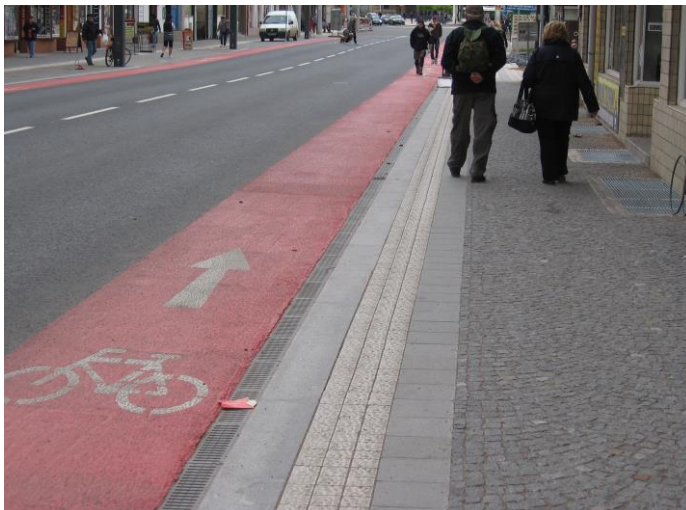
Cycling path in the same level as pedestrian path

Cycling path is correctly separated from other pedestrian path. Blind people identify this tactile (30 cm wide paving) arrangement by white stick.

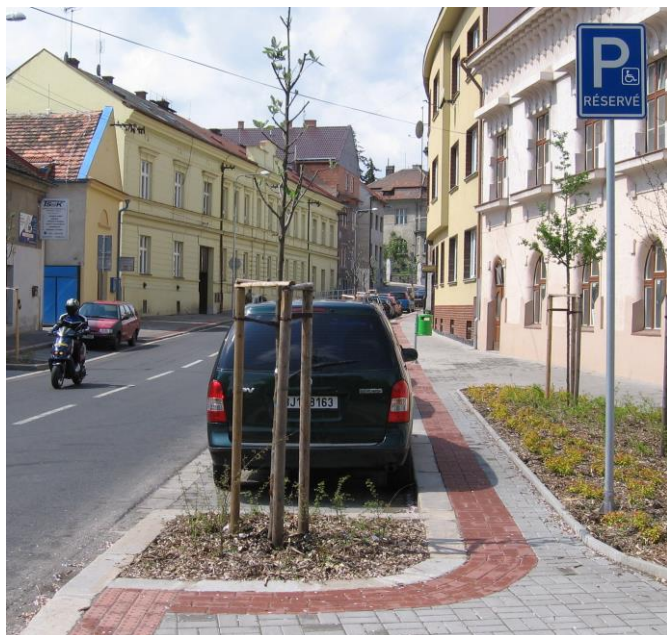
Parking place for PRM

Narrow parking place for PRM. People in wheelchair get out car directly to the road left.

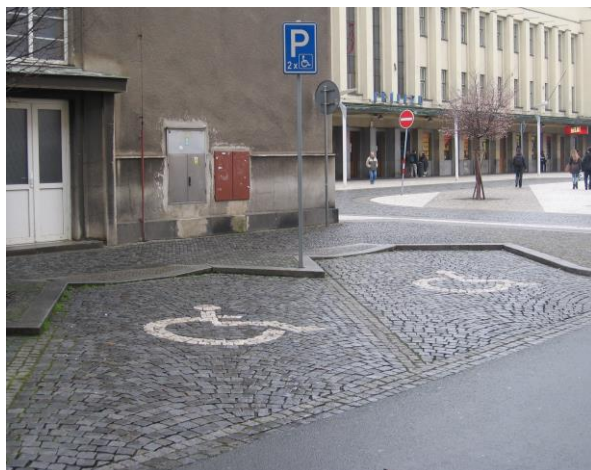
Parking place for PRM

Correct parking places for people with reduced mobility – lowered kerb (max. height 2 cm) is important for people in wheelchair. Important is also marking of these places with official emblems.

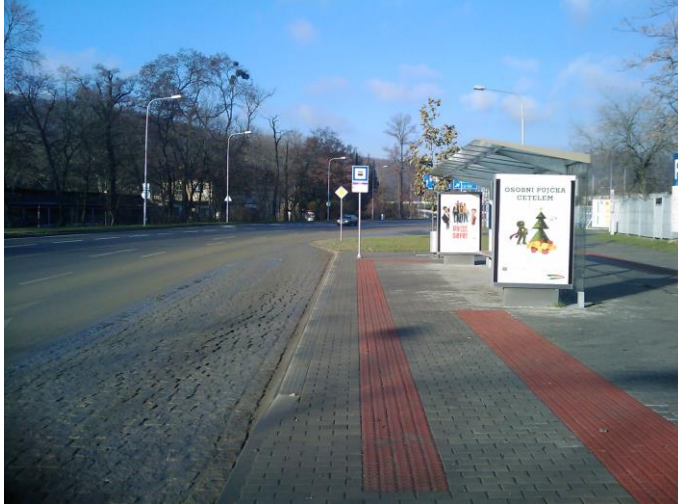
Bus stop

Incorrect tactile paving (red belt on the left - near the boarding edge) – for blind people confusing arrangement.

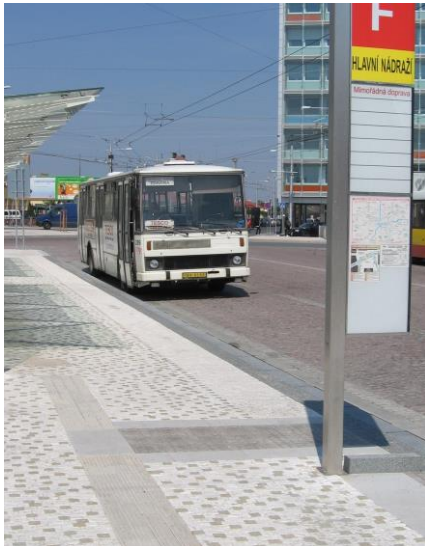
Tactile guiding on the bus stop

Correct tactile guiding for blind people on the bus stop. The tactile paving guides blind people to the stop pillar or to shelter. There are colour contrast paving (no tactile) near the boarding edge only.

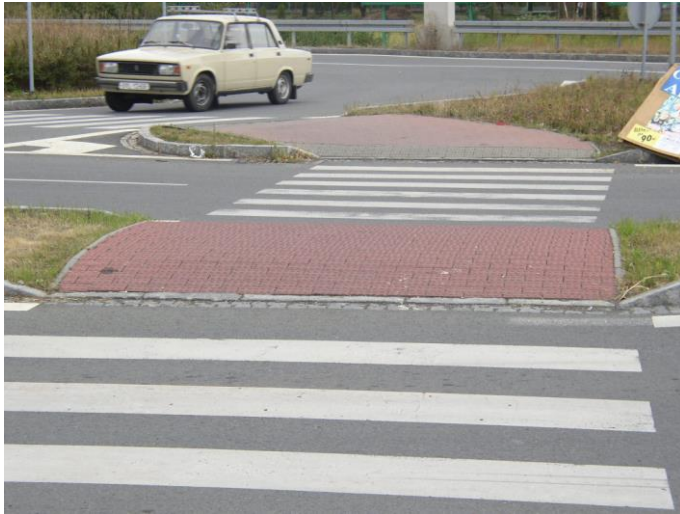
Pedestrian crossing with isle

Pedestrian crossing without arrangements for blind people. There is whole isle space built from tactile paving – this arrangement don't guide blind people.

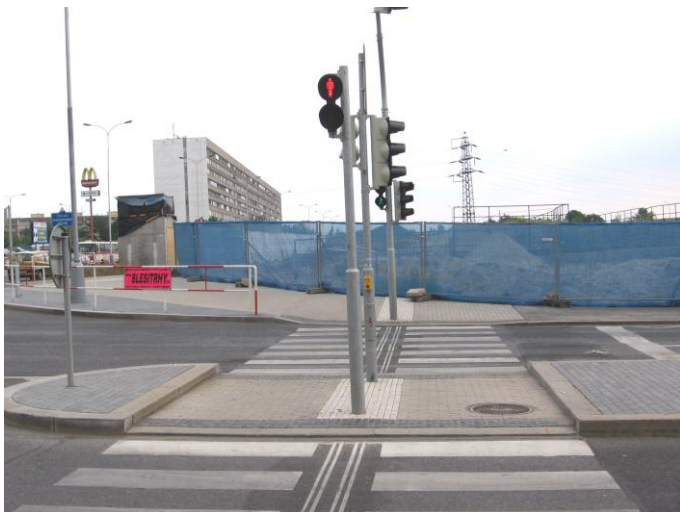
Pedestrian crossing with isle and traffic lights

Pedestrian crossing with traffic lights and isle with correct tactile arrangements: warning and guide lines for blind people on the isle and in zebra.

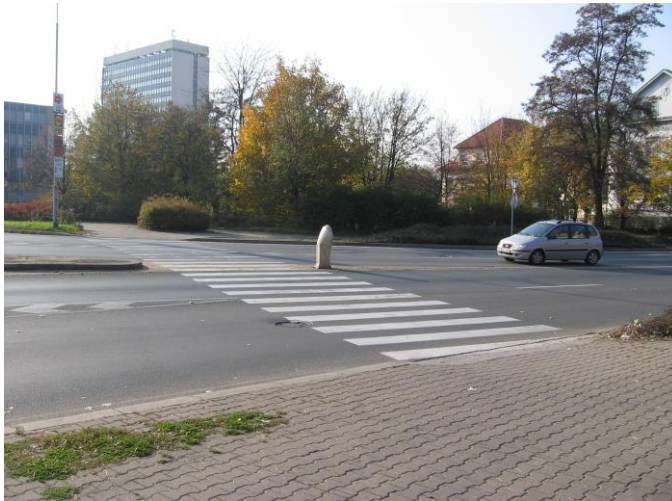
**Pedestrian crossing****Commentary:**

Pedestrian crossing without tactile guiding for blind people. This crossing (about 20 m long) is not usable for blind people.

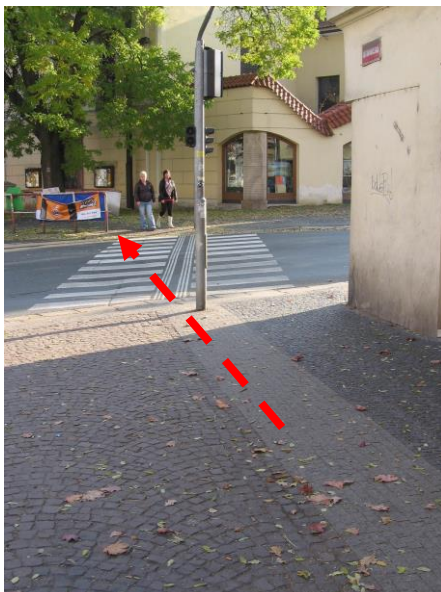
**Pedestrian crossing – blind people guiding****Commentary:**

This solution guides the blind people out of zebra area – very dangerous mistake. Relatively often mistake of crossing adaptation in the Czech Republic and other countries too.

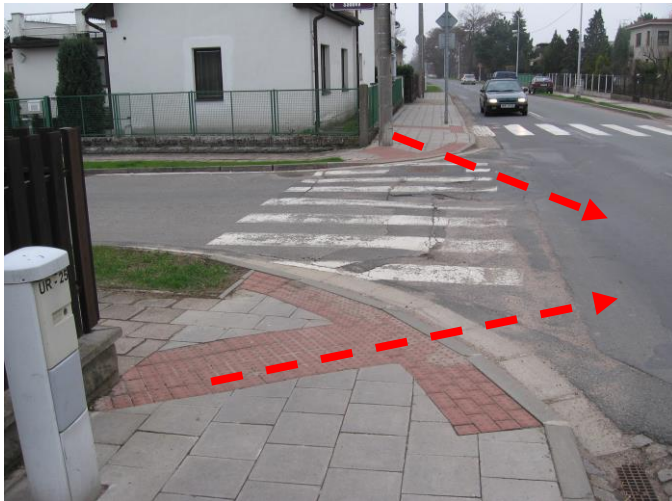
Pedestrian crossing

Very often mistake (in each V4 countries) – tactile guiding leads the blind people out of zebra – to the road!

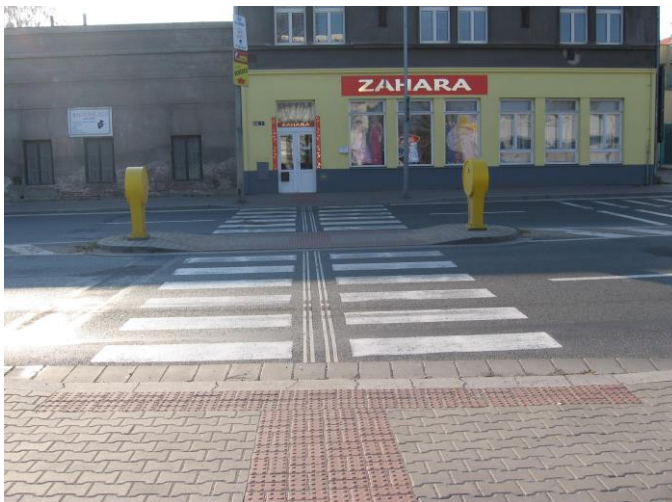
Pedestrian crossing (with isle)

This crossing is good adapted for independent and safe using of blind people. There is tactile guiding and warning belts created on the pedestrian path, in the road and on the isle too.

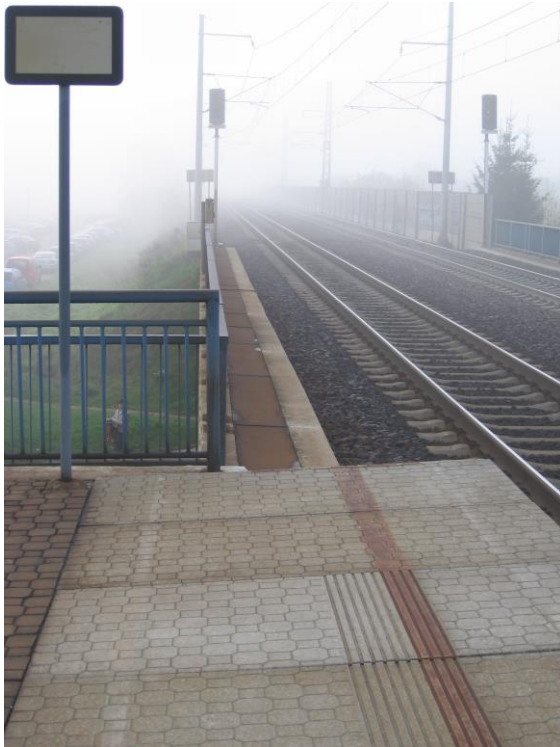
End of railway platform

The tactile (grooved) guiding line is short; it must lead up to end of platform; allowable distance between end of grooved guiding line and the rail is 0,3 m. This is very dangerous mistake for blind people!

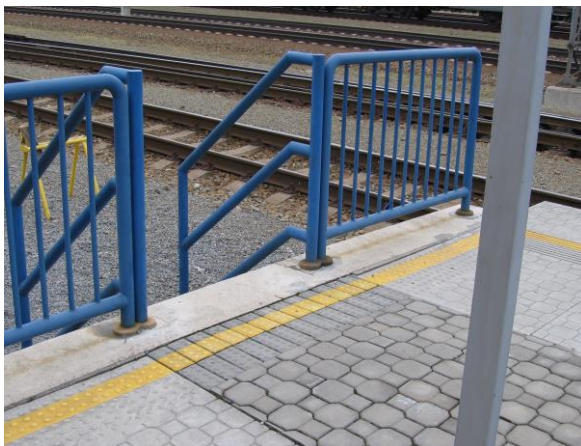
End of railway platform

Correct tactile adaptation on the end of platform (warning belt, colour contrast, safety rail).

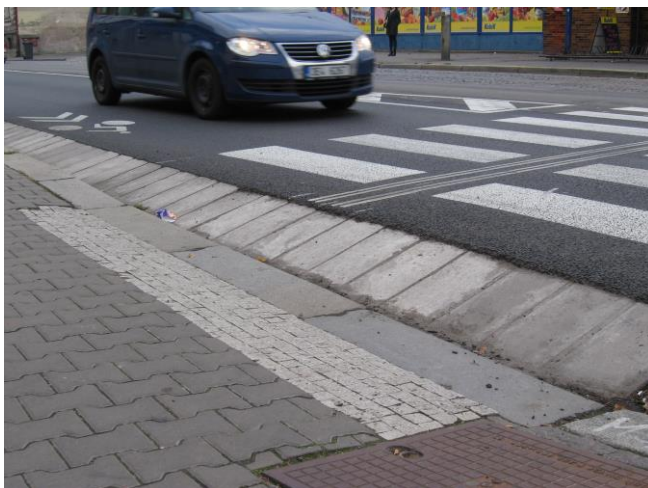
Pedestrian crossing – declination

Dangerous declination on the interface pedestrian way and crossing - risk of turn over (to back) for people in wheelchair.

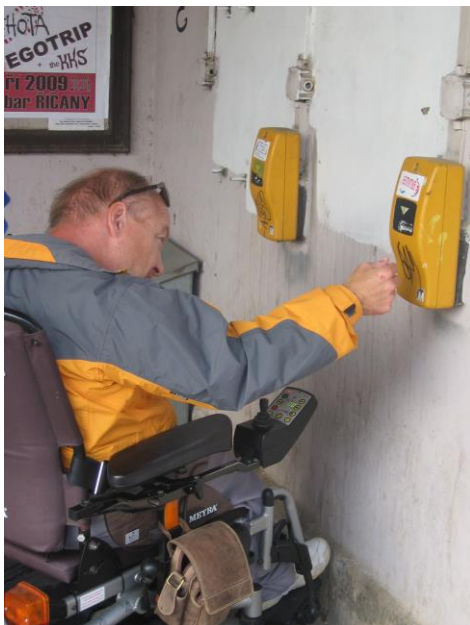
Manoeuvring space and operating height

Good placing of items in manoeuvring space and operating height for people in wheelchair (0,6 – 1,2 m in the Czech republic).
