Country

Hungary

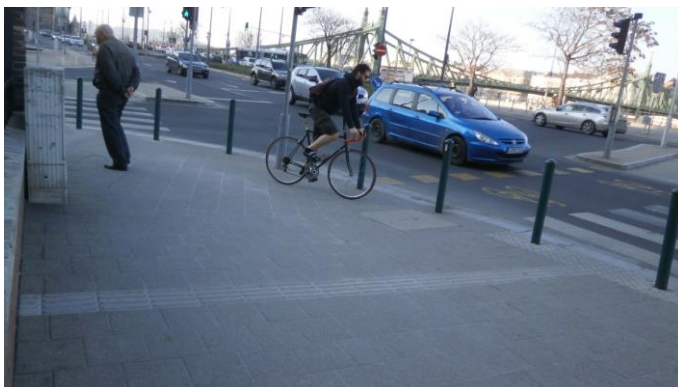
Pedestrian crossing – guiding line

Grooved guiding line leads the blind from fence to the pedestrian crossing – good solution for blind.

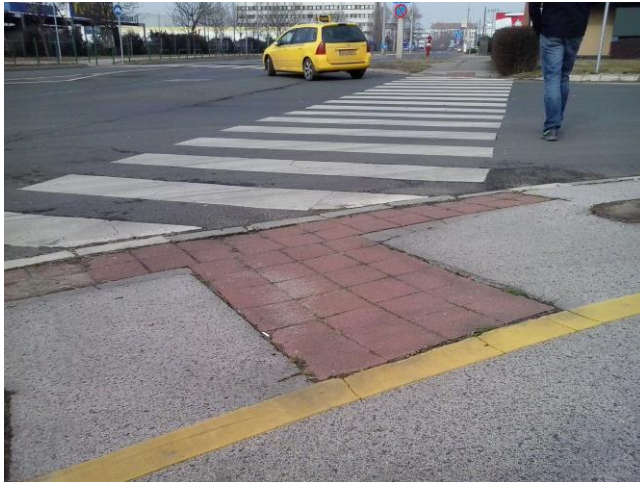
Pedestrian crossing

Signal belt without tactile contrast and in absolute incorrect direction – this dangerous arrangement leads the blind to the center of intersection!! Often mistake in all V4 countries.

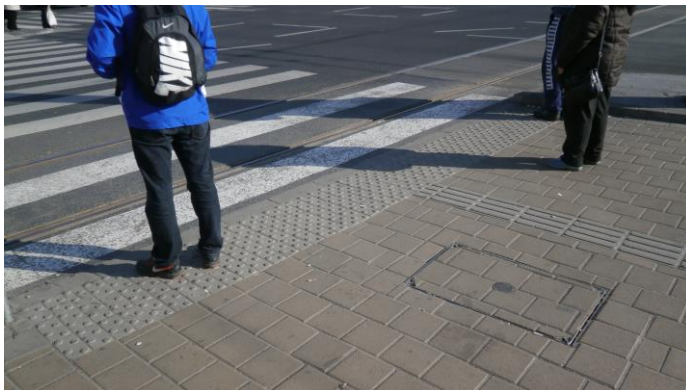
Pedestrian crossing

Tactile pavement – warning belt on the interface road – pedestrian path and grooved guiding line is leading in the axis the crossing.

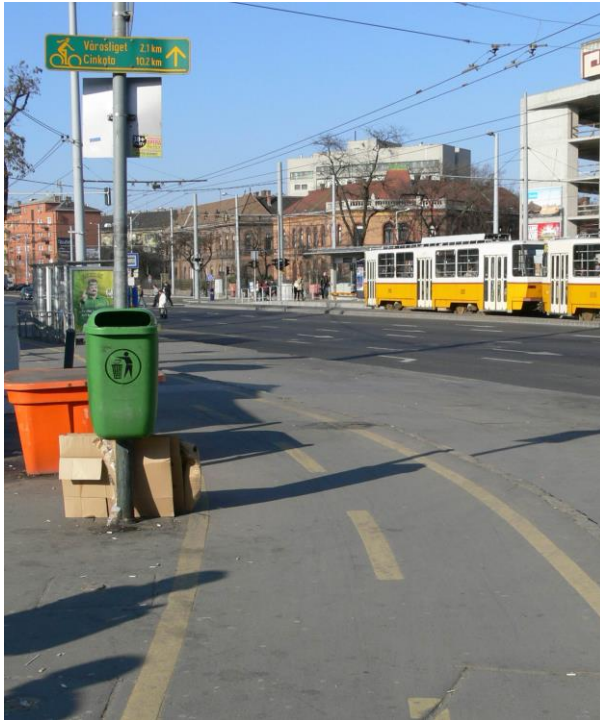
Bicycling path in the same level as the pedestrian path – without tactile interface – dangerous for blind people.

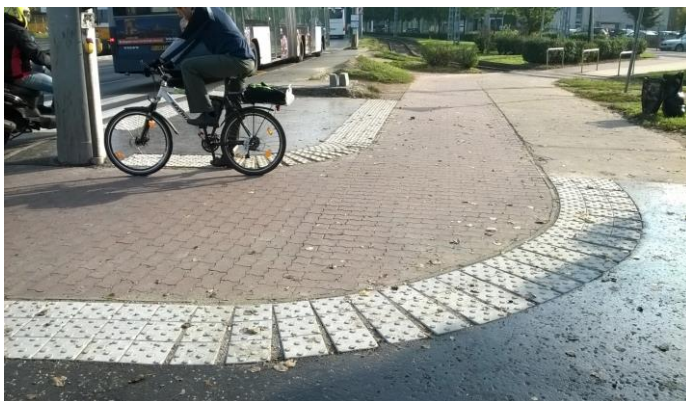
Bicycling path

Pavement and bicycle path on the same level, with tactile marking for blind people.

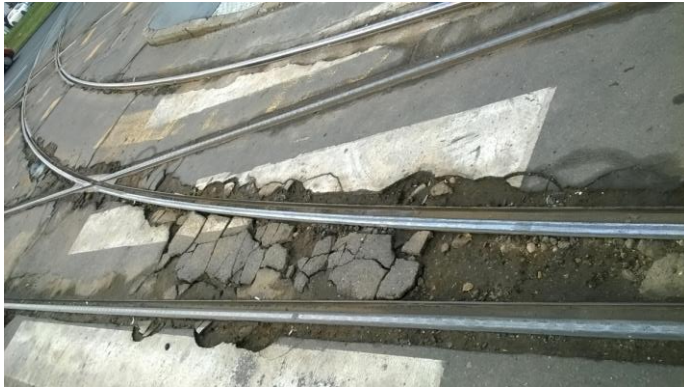
Crossing of tram track

Obvious problem - practically inaccessible for wheelchairs users, dangerous for other pedestrians.

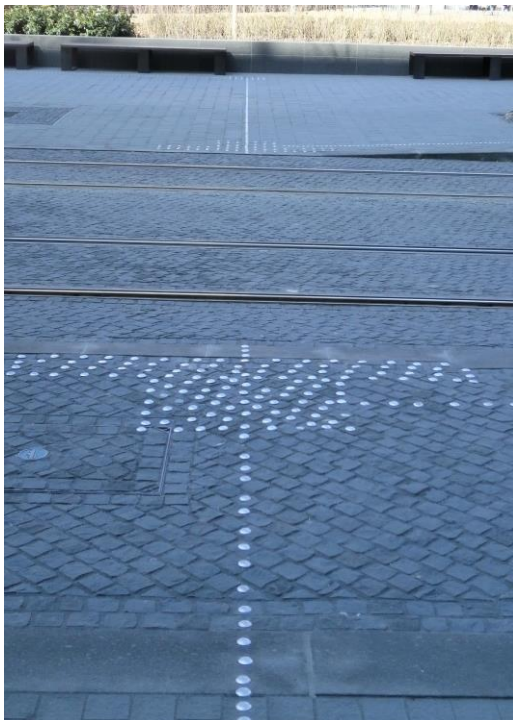
Tram tracks crossing

Poor arrangement for blind people – this tactile guiding from steel elements is not locating by white stick.

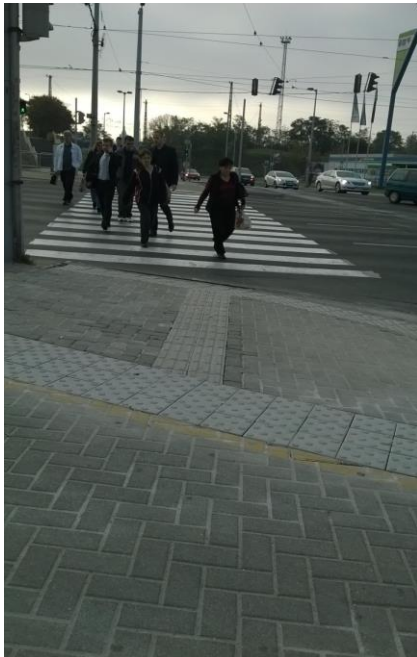
Pedestrian crossing

Guiding lane must point to the other side of the street in the axis of the pedestrian crossing – this example leads the blind to the center of the intersection.

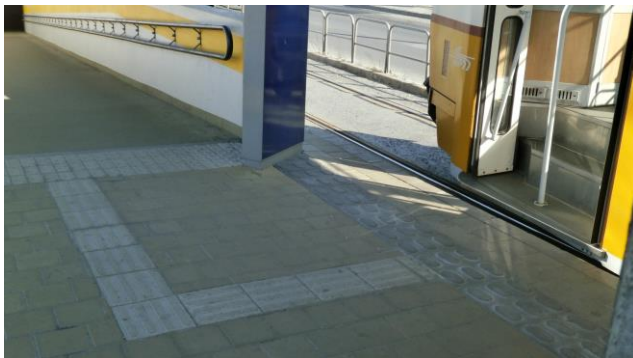
Tram stop

Tactile guiding from the access path to the tram first door.

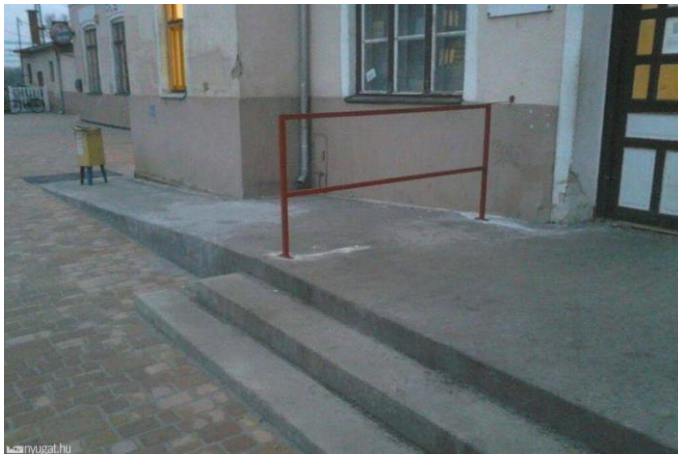
Isolated ramp

Negligence during planning and construction.

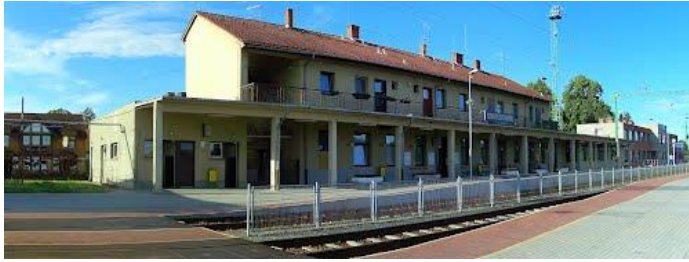
Barrier-free station

In-level access to platforms, ticket office and waiting hall. Good solution for wheelchair; there are missing tactile guiding for blind people.

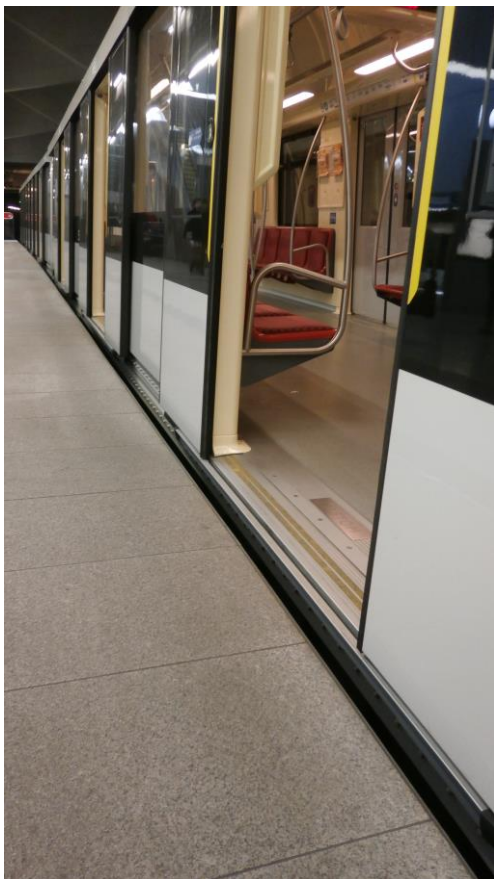
Underground vehicles

Easy access for people in wheelchair to the underground vehicles.

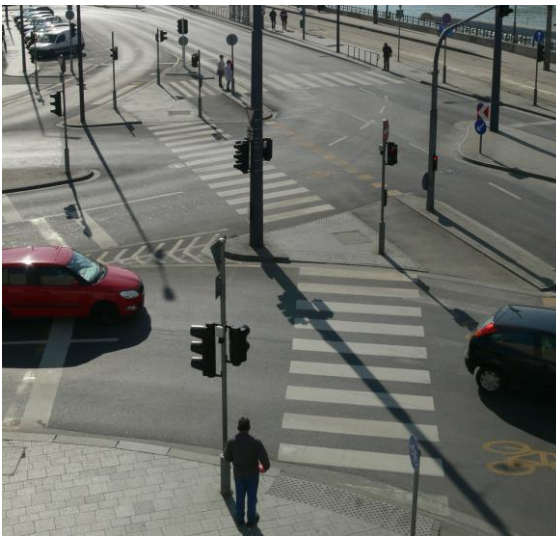
Crossing without guiding lines

This crossing is not safe and independent usable for blind people – there are missing the guiding lines on the pedestrian path and also on the isles.

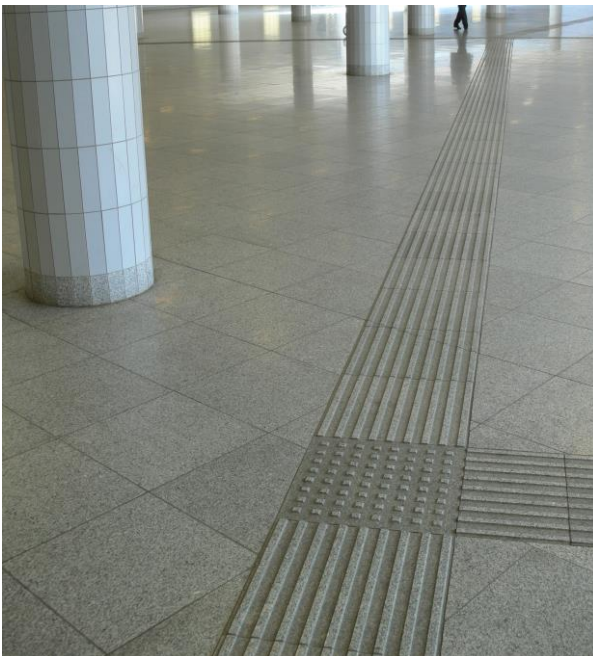
Guiding line in interior

Correct tactile (grooved) guiding line with turning (right) in area of Budapest railway station.

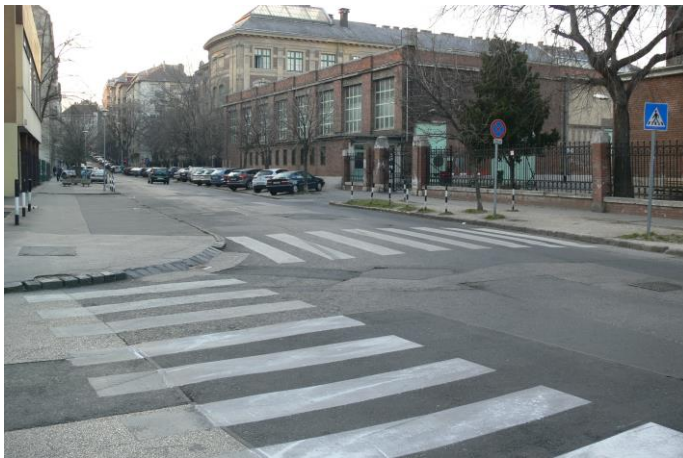
Pedestrian crossing

Inaccessible pedestrian crossing for blind; only one site of crossing has adaptation for people in wheelchair but declination of the kerb is unacceptable.

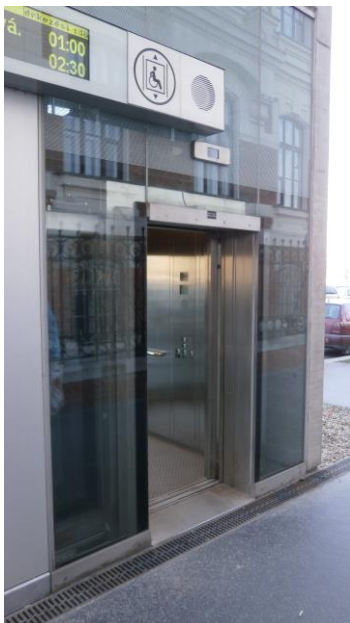
Barrier-free access to underground

Access to Budapest metro by lift (all stations on the Line 4) – good solution for wheelchairs and other passengers with reduced mobility – accompany of baby carriages, old people, people in convalescence (with short-time reduced mobility) etc.

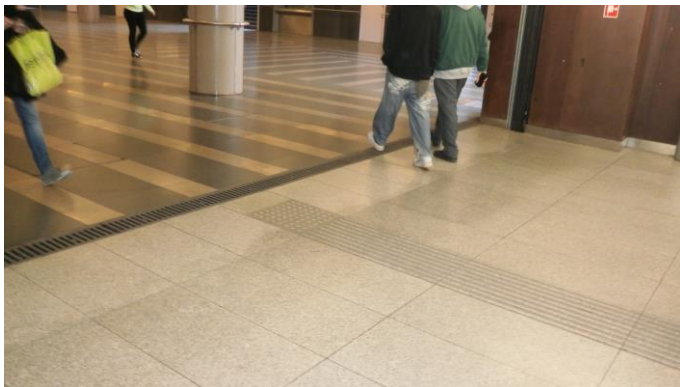
Guiding line in interior

Incorrect arrangement of grooved guiding line in underpass of underground: this guiding line does not continue – poor solution for blind people. Often poor arrangement in all V4 countries.

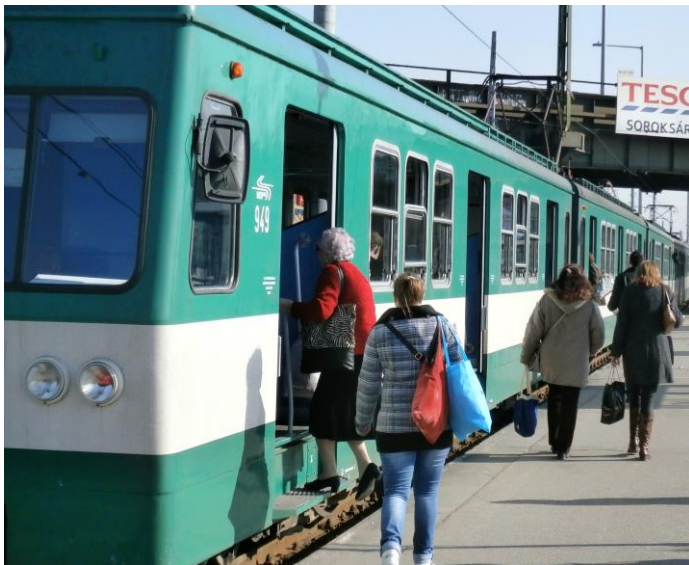
Suburban rail platform

Older type of suburban train and low platform – unacceptable combination for people in wheelchair, accompany of baby prams and partially for seniors.
