Country

Slovakia

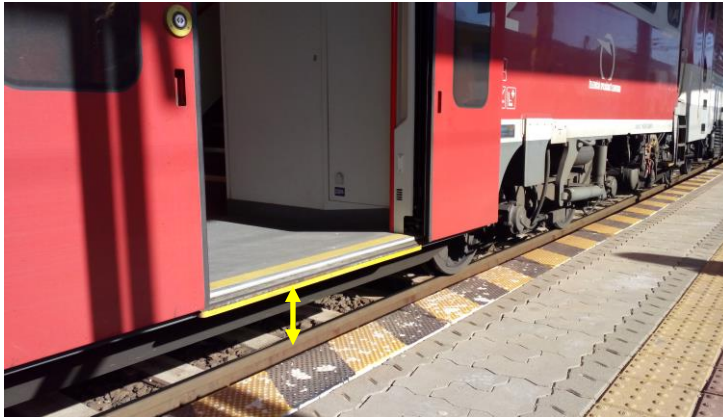
Vehicles versus platform

Passenger carriage with higher level of floor than the platform – not usable for people in wheelchair and other compensatory aides.

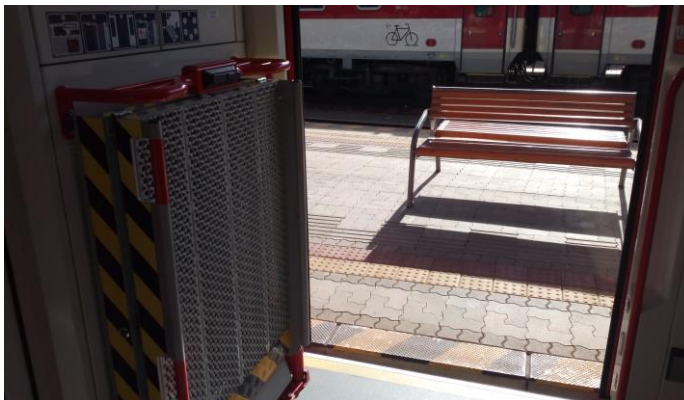
Railway platform versus vehicles

Low-floor train and railway platform with high 550 mm – necessary solution for people in wheelchair. The ramp for wheelchairs is built-in in vehicles.

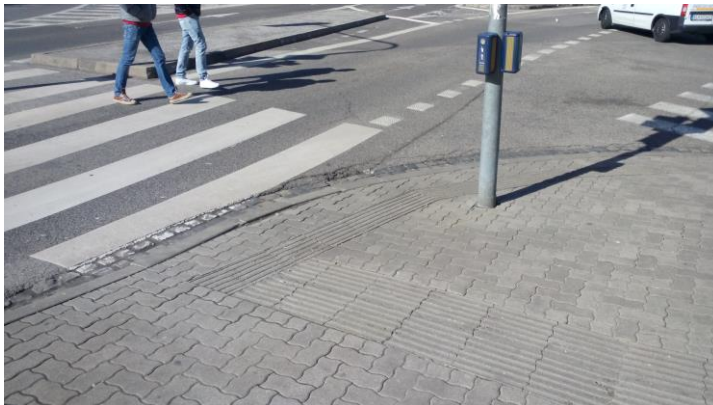
Pedestrian crossing

Confusing solution of tactile guiding for blind people.

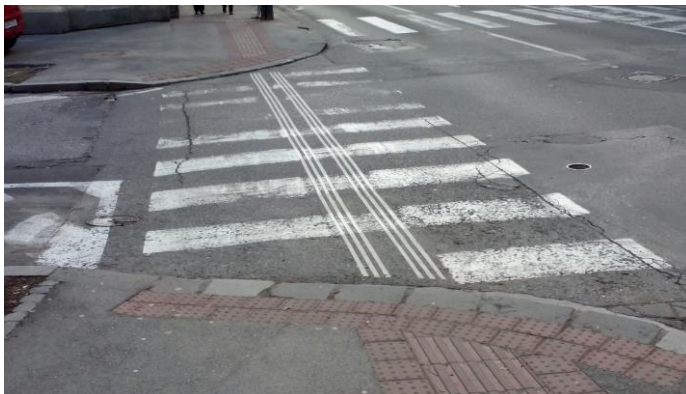
Pedestrian crossing

The warning belt, signal belt and guiding belt in zebra are correctly applied. Good – safety solution for blind people with white stick.

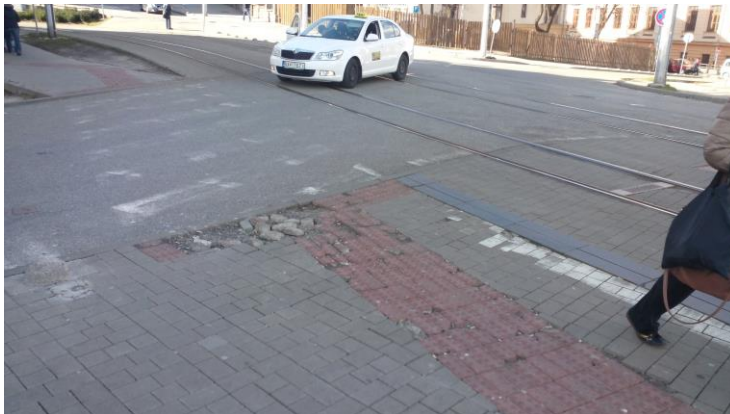
Pedestrian crossing

Incorrect surface of tactile guiding lines (signal, warning belts) for blind people. Dangerous for other pedestrians too.

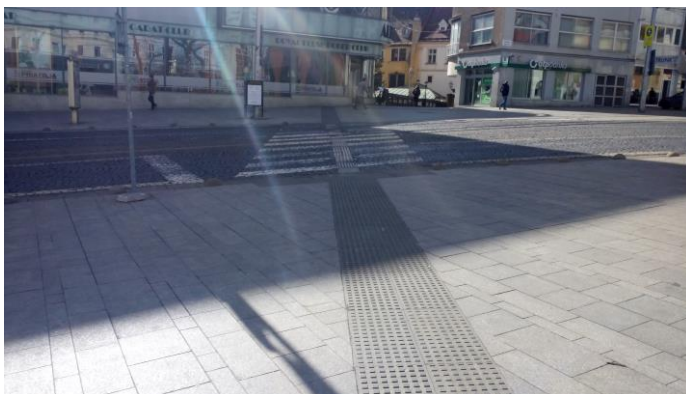
Pedestrian crossing

Correct guiding line (signal belt) from tactile paving, it leads the blind in direction (axis) of the zebra.

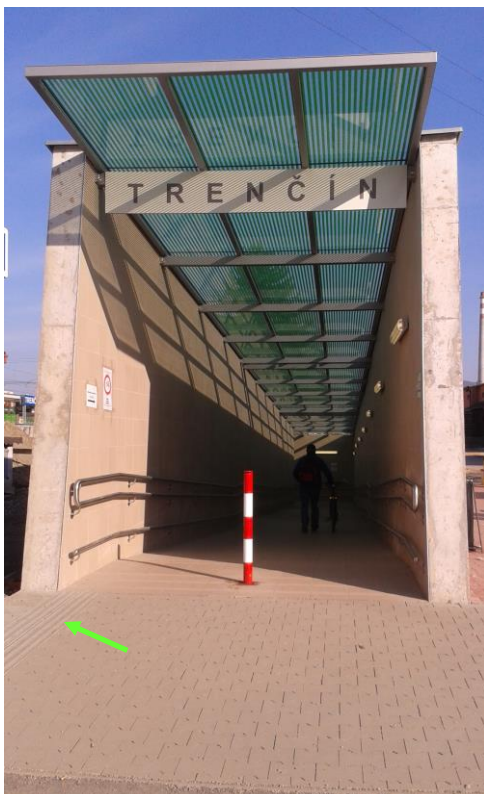
Access to the platform

Good access to the railway platform for all – wheelchairs, passengers with bicycles, baby prams also for blind people (green arrow shows grooved guiding line for blind people).

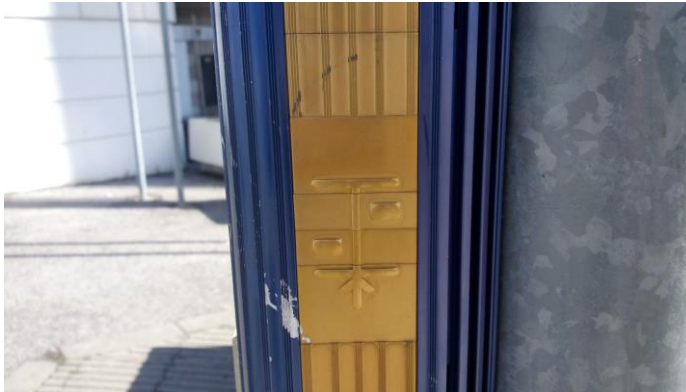
Orientation on the pedestrian crossing

Tactile – embossed – marking on the signaling pillar of pedestrian crossing. Blind people “read” the situation on the pedestrian crossing by fingers and identify direction of their next walking.

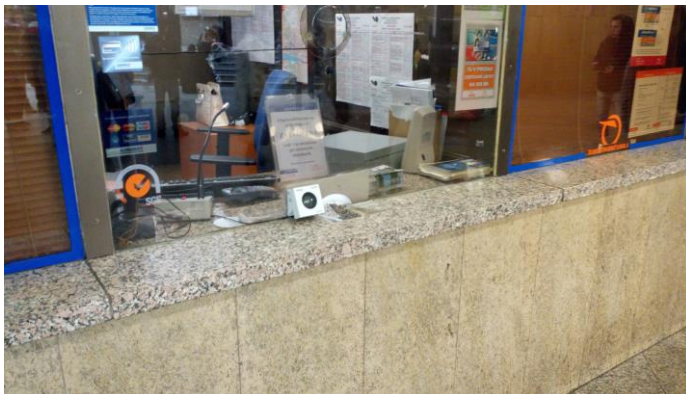
Information window for hard of hearing passengers

Information window with equipment for PRM, especially for hard of hearing people – transparent glass is necessary for lip-read, microphone for increasing of spoken word. Small mistake – missing marking of window (international symbol of accessibility).

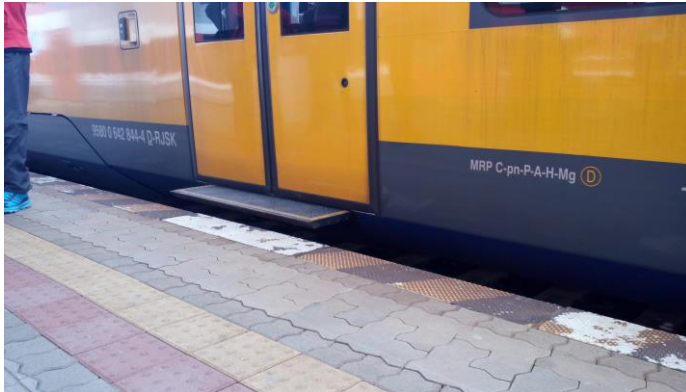
Platform versus vehicle

Good solution of bridge the gap between vehicle and railway platform by way the telescopic step.

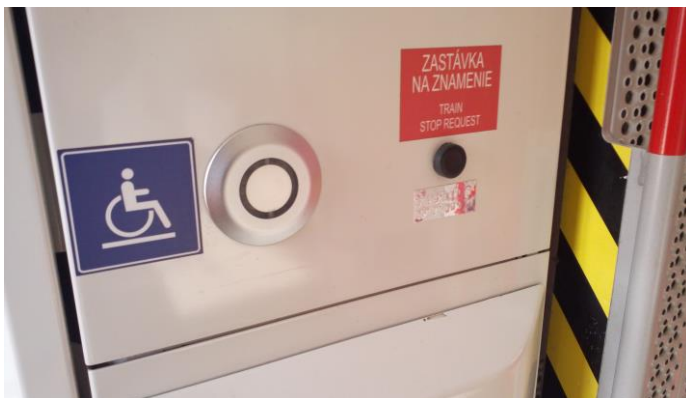
Communication with engine-driver

Communication button for wheelchair – information to engine-driver about using of ramp.

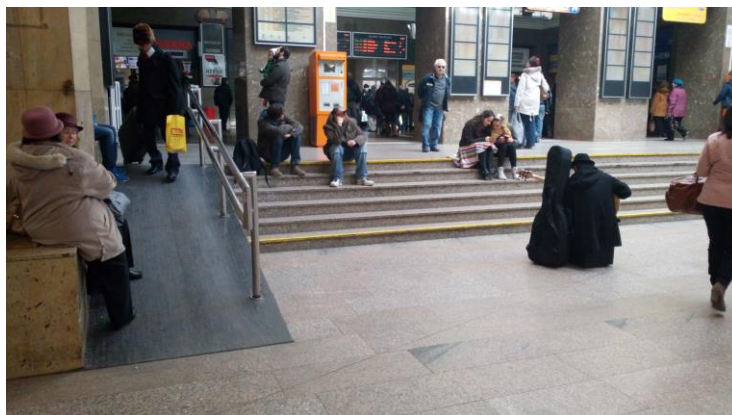
Passenger hall

Incorrect solution of ramp in passenger hall – unacceptable declination – not usable for people in wheelchair.

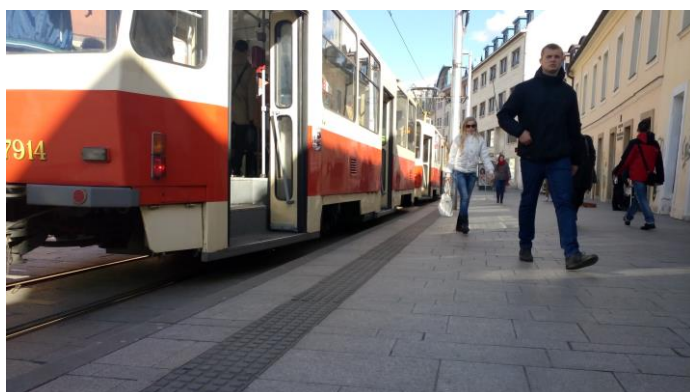
Tram stop – good for blind,
poor for wheelchair

Tactile guiding line for blind people – blind people define interface between safe and dangerous area; inaccessible vehicles for people in wheelchair – (max. acceptable vertical difference between boarding edge and floor of vehicles (tram) is 200 mm, 160 mm respectively).

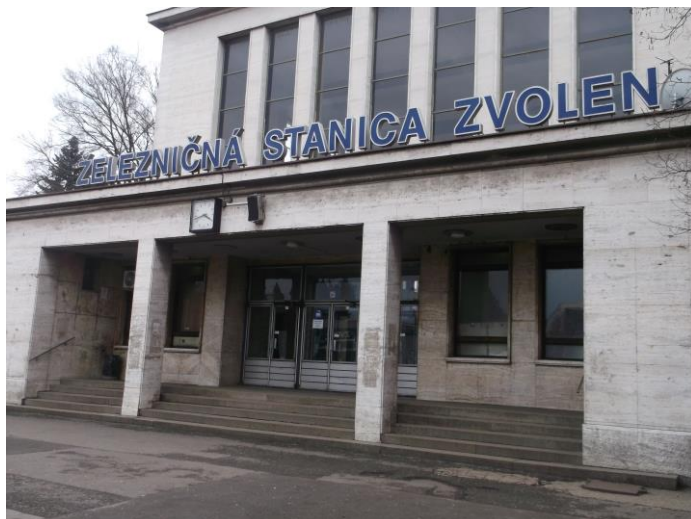
Access to the passenger hall

Access with stairs – without ramp or alternative entrance – not usable solution for wheelchairs, accompany of baby carriages etc.

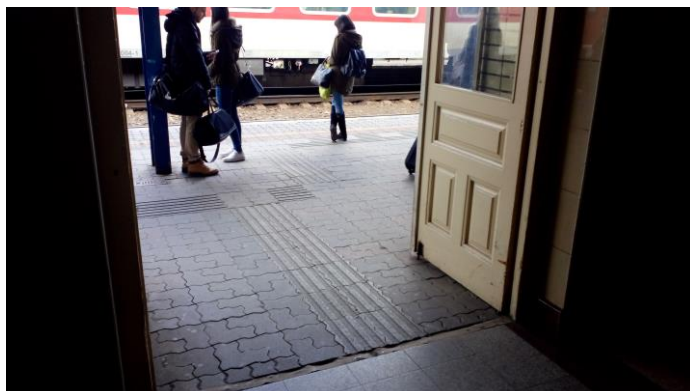
Tactile guiding line for blind people is leading from railway platform to passenger hall. In-level access for people in wheelchair.
